Hydraulic Model Investigation Of Marsh Creek Dam Principal Spillway In Contra Costa County, California

ARS-NC-35 February 1976

Study conducted by the Agricultural Research Service UNITED STATES DEPARTMENT OF AGRICULTURE

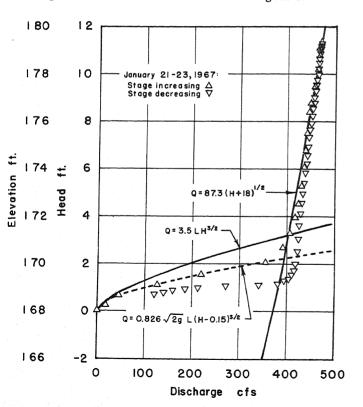
FIGURE 5.—Prototype head-discharge relationships.

6. . . . the recorded inflow hydrograph was routed through the reservoir using the storage-indication procedure. The calculated values of the outflow obtained through this process were plotted against corresponding (in time) pond stages obtained from the record. There was good agreement between measured and computed performance curves especially in the range of conduit control. At the low rates (weir control) the measured head was systematically lower than the predicted one and more so in the falling than in the rising limb of the hydrograph.

Kalkanis' weir flow and conduit control curves have been added to figure 5 to illustrate his comments.

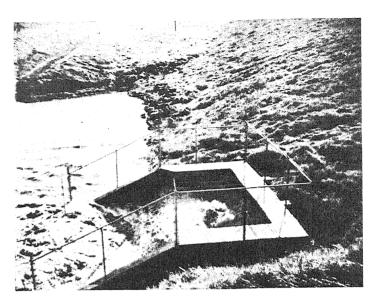
- 1. At 10:10 a.m. the water surface at principal spillway was indicated to be (-) 0.1', by the painted scale on the hood, below the crest which is supposed to be constructed at elevation 168.0'. An audible roar of falling water could be heard even when inside the recorder building on top of the dam. All of the (8) 4" \emptyset vent holes on the north face of the spillway appeared to be partially to completely plugged with debris. (Ref. photo No. 1).

Photo No. 1.—1/27/69 w/s [water surface] at inlet indicated at -01 10:10 a.m.

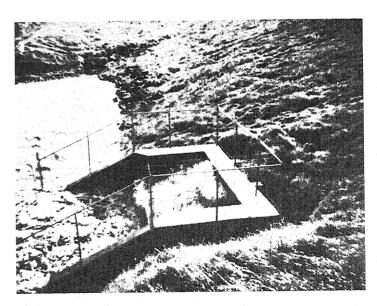
- 2. At 10:15 a.m. the discharge in the energy dissipator was turbulent and it appeared that the $4.5'\times4.5'$ spillway tube was flowing full. (Ref. photos No. 2 & 3).

Photo No. 2.—1/27/69 10:15 a.m. [No air expelled.]

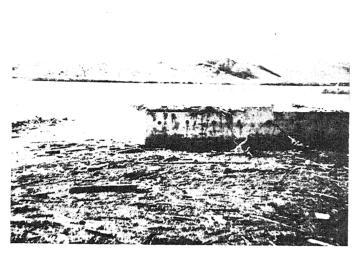
Photo No. 3.—1/27/69 10:15 a.m. [Air transported through the barrel is expelled intermittently.]

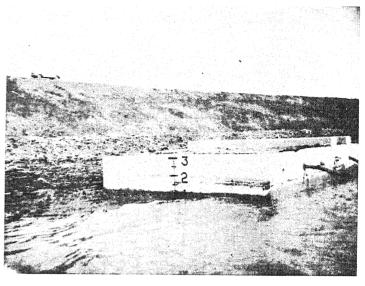
- 3. At 10:25 a.m., while in the recorder building, I realized that the audible flow had ceased. I now estimate the time from when I last consciously heard the flow to when I realized it had stopped to be no more than a few minutes. At 10:32 I recorded the water surface at the spillway hood to be an indicated (—) 0.2'. (Ref. photo No. 4). Later scrutiny of the photo indicated that several of the vent holes appearing partly plugged on photo No. 1 were open in photo No. 4. Although hardly discernible, photo No. 5 shows the outflow area to be tranquil with no visible flow from the dissipator.

Photo No. 5.—1/27/69 10:32 a.m. Spillway stopped flowing.

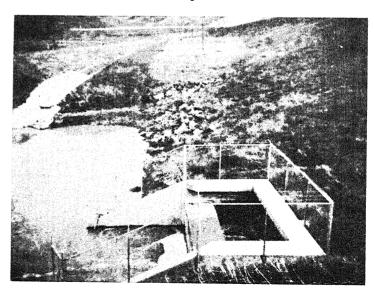
1. Photo No. 6 shows the indicated water surface to be 1.0' over the principal spillway crest. A very slight audible sound was heard at the spillway which could not be readily heard from on top the dam. Note the debris in some of the 8 vents on the south face of the hood.

Photo No. 6.—1/29/69 West face of Princ. Splway [principal spillway]. w/s [water surface] appeared to be at indicated 10 above crest elevation. 2:30 p.m.

10. On January 29, the pond level was at elevation 169.0 (one foot above crest). The slightly audible sound was indicative of the control being at the crest (weir control). The flow was probably close to 100 cfs. The barrel, however, was flowing practically full and the depth of flow over the end sill of the dissipator estimated from one of the pictures taken by Mr. Jewett was about 4.3 ft.

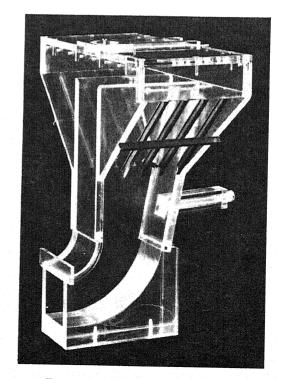
Figure 6.—The model drop inlet.

All critical drop inlet dimensions were modeled to exact scale. However, the wall thickness deviated from exact scale to permit the use of stock thicknesses of plastic. The model inlet is shown in figure 6 and its dimensions are shown in figure 7. The trashrack was made from an extruded plastic I-beam section 0.375 by 0.187 inch whereas the scaled dimensions should have been 0.333 by 0.172 inch. The drop inlet ladders were not modeled.

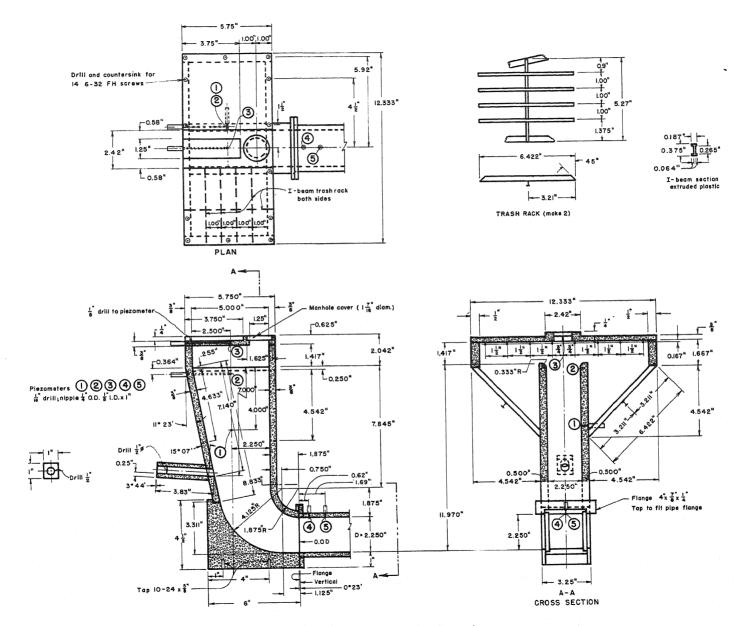
Figure 7.—Model drop inlet dimensions.

Piezometers to measure the pressures in the drop inlet and at the barrel crown are shown in figure 7: number 1 at the drop inlet midheight, number 2 at the end on the sidewall crest curve, number 3 at the center of the antivortex plate, and numbers 4 and 5 on the barrel crown near the barrel entrance. Additional piezometers were located at 10D intervals along the barrel invert, the first piezometer being 15D from the barrel entrance. These were used to determine the hydraulic gradeline and friction loss in the barrel.

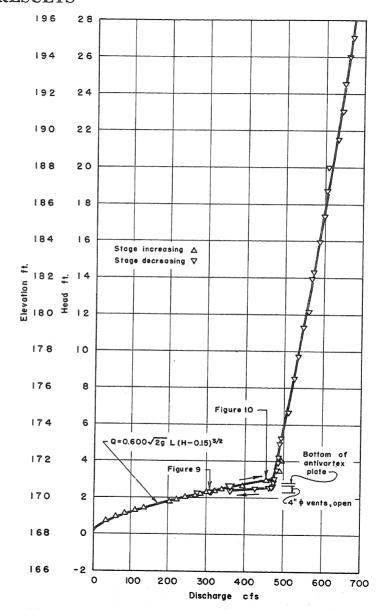
Figure 8.—Model head-discharge relationship: vents open.

For discharges up to 473 c.f.s. the head-discharge relationship was controlled by the weir at the drop inlet crest. For discharges less than 270 c.f.s. the nappes clung to the sides of the drop inlet, the barrel was part full, and the barrel flow was supercritical except near the barrel exit where there was an undular hydraulic jump.

Unstable flow existed in the barrel at discharges of 300 to 320 c.f.s. There was a hydraulic jump in the barrel. The air entrained in the jump was transported as small bubbles (fig. 9(a)) or larger slugs (fig. 9(c)) on the barrel crown. The jump position was unsteady, slowly moving back and forth in the barrel or remaining

For decreasing stages, figure 8 shows that full-pipe control existed until the head reached 2.6 ft, 0.4 ft lower than on increasing stages. At this head air entered the drop inlet through the four vents on the upstream side of the drop inlet nearest to the drop inlet centerline. Water entered through the outer four vents in the upstream endwall. The air was transported through the barrel and the control was changing from full pipe to a siphon regulated by the entering air.

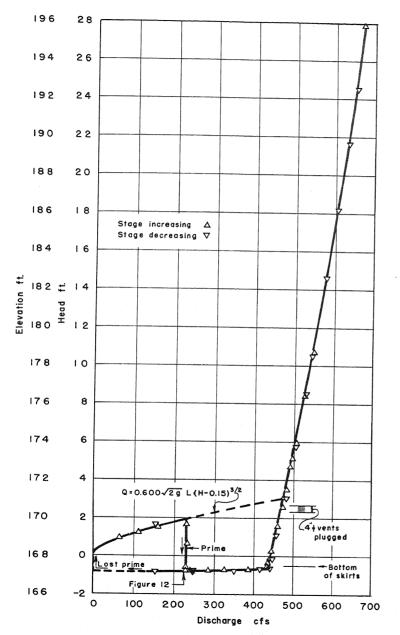
Figure 11.—Model head-discharge relationship: vents closed

The head-discharge relationship with the endwall vents plugged is shown in figure 11.

As the discharge increased from 229 to 433 c.f.s., the drop inlet gradually filled and the air entering under the skirts gradually decreased. One of the weir nappes clung and the other sprung free.

There were surface vortices at the ends of the antivortex plate for heads between 2.5 and 11 ft. Air bubbles were trapped under the upstream outside corners of the antivortex plate at heads exceeding 4 ft. Air was trapped over the drop inlet at a discharge of

500 c.f.s. and the pressure blew off the manhole cover, an event which was observed only once during the tests.

For decreasing stages the spillway remained primed until the discharge decreased to 153 c.f.s. When the spillway lost its prime the discharge suddenly decreased to zero since the weir head was then -0.8 ft. Because the inflow to the headpool was also 153 c.f.s., the reservoir filled to the drop inlet crest without outflow and further filled to a stable weir head of 1.6 ft with outflow.

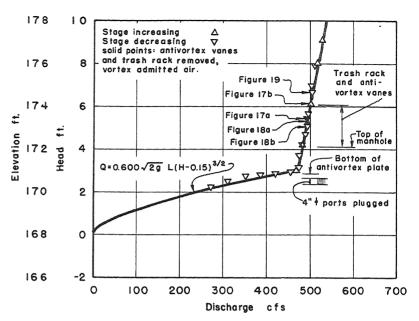
Figure 16.—Model head-discharge relationship: vents closed, manhole cover removed, trashrack and antivortex device over manhole.

Similarly, the trashrack cover was used only after the trashrack and antivortex vanes became submerged. At times during the tests the trashrack and antivortex device were removed to see if vortices would form; they did.

The head-discharge relationship with the endwall vents plugged, the manhole cover removed, and a trashrack and antivortex device installed over the open manhole is shown in figure 16. This headdischarge relationship is identical to that of figure 13.

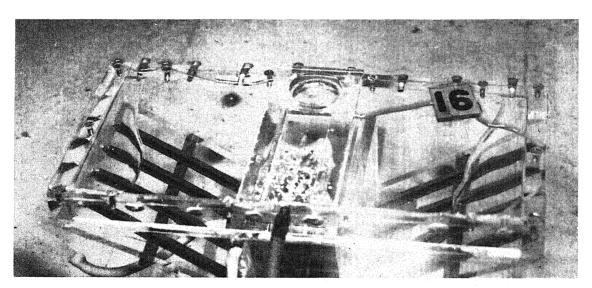
Figure 20.—Little loss in head between the headpool and drop inlet. Water is standing in the manhole opening. The head on the spillway crest is 3.7 ft, 0.9 ft above the bottom of the antivortex plate. The pressure at the center of the antivortex plate is 0.5 ft. The pressure drop between

the headpool and the cover over the center of the drop inlet is only 0.4 ft or $-0.04h_{vp}$. Air is trapped over the upstream end of the drop inlet and upstream outer ends of the antivortex plate.
